## EXTENDING EARTH MOVING BUCKET LIFE

### Earth moving equipment case study

Author: Tamás Sándor PhD, IWE  
Global Business Development Manager  
Wear Protection and Special Applications

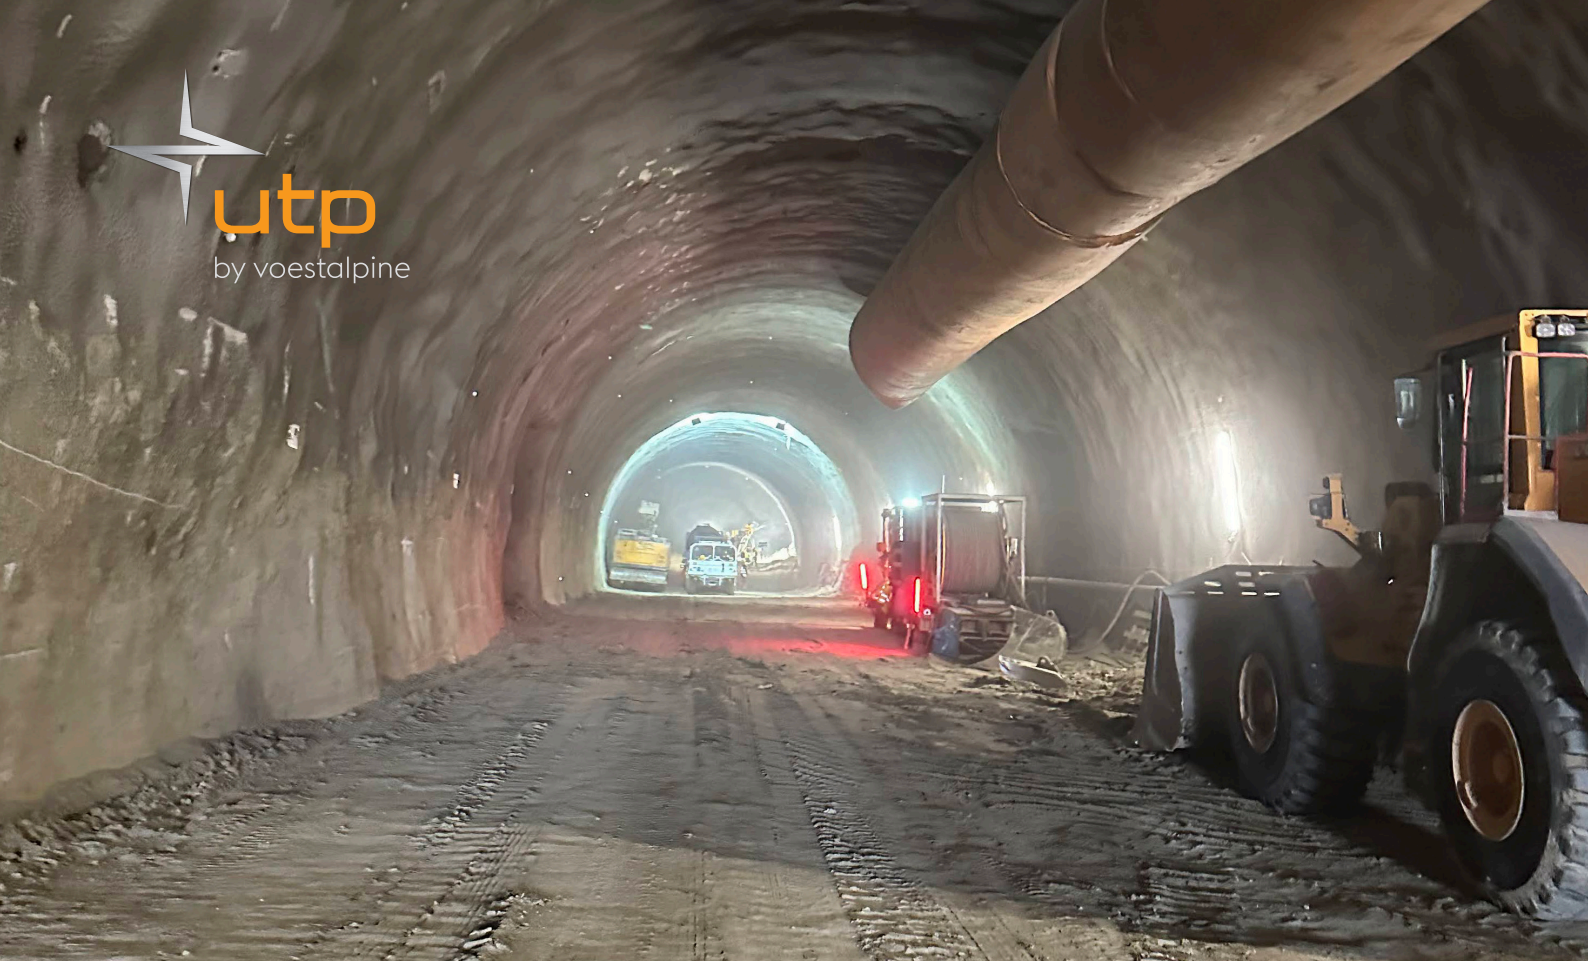
Figure 1: Tunneling construction site.

Companies involved in road construction and tunneling usually operate a fleet of earthmoving equipment for the different construction sites in which they are involved. (Figure 1)

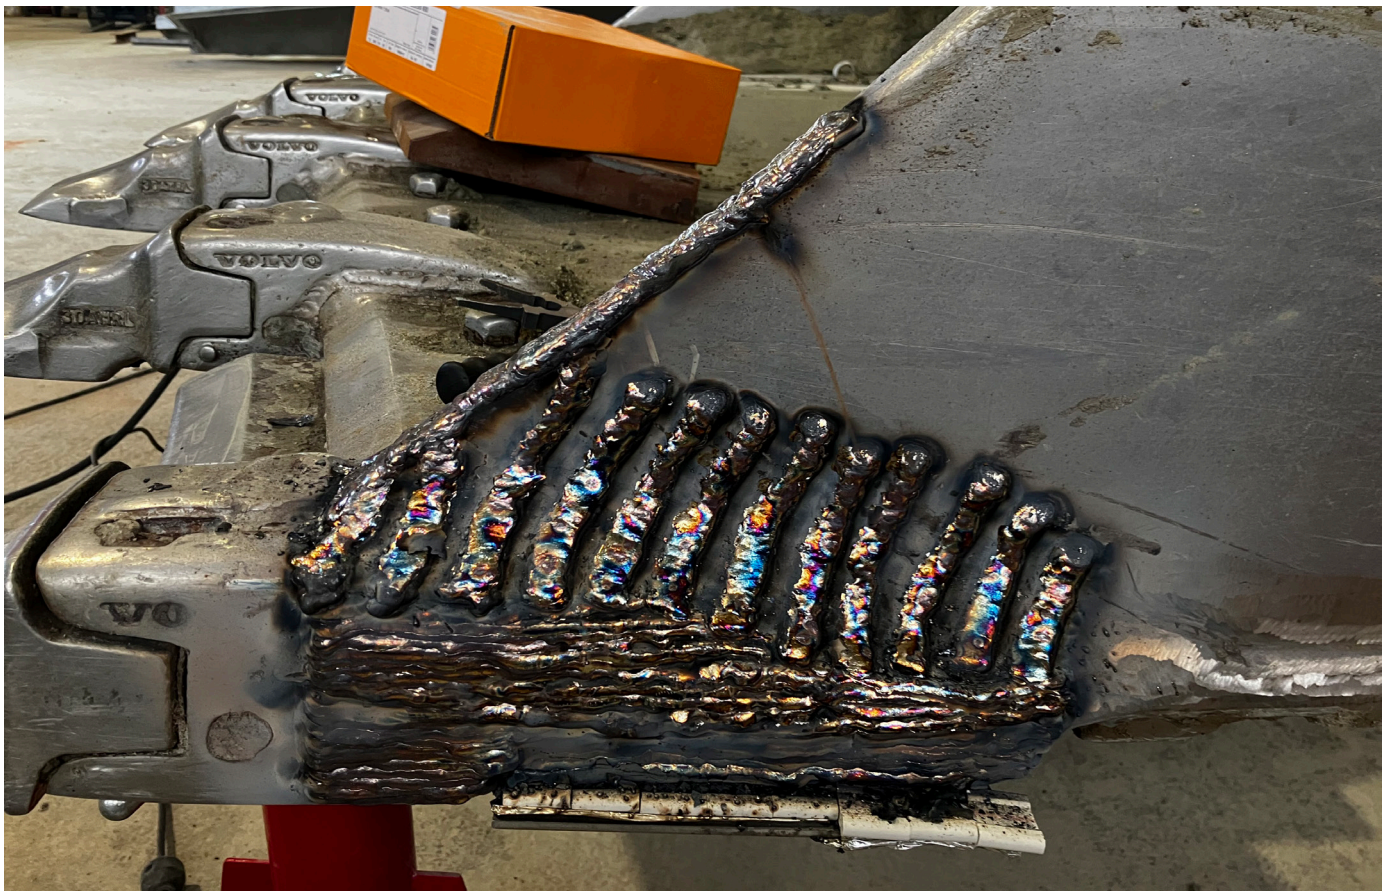
Figure 3 B.) - Buffer layer applied using the all-positional rutile Böhler FOXcore 309L-T1 welding wire.

A FOXcore 309L-T1 cored wire was used for the buffer layer to achieve a significantly higher deposition rate than the 312 type solid wire. By using FOXcore 309L-T1, the welding speed when welding of the first layer in welding positions PC and PF was able to be doubled. In addition, a 5 mm buffer layer thickness was achieved in a single pass (Figure 3. B.), eliminating the need for a second layer. The result is improved efficiency and reduced cost for repair work.

Welding Parameters for FOXcore 309L-T1	Buffer Layer
Diameter	1.2 mm
Wire feed speed	7.6 m/min
Current	210 - 220
Voltage	24.5 V
Stick-out	20-25 mm
Shielding gas	M 21 (EN ISO 14175)
Polarity	DC+

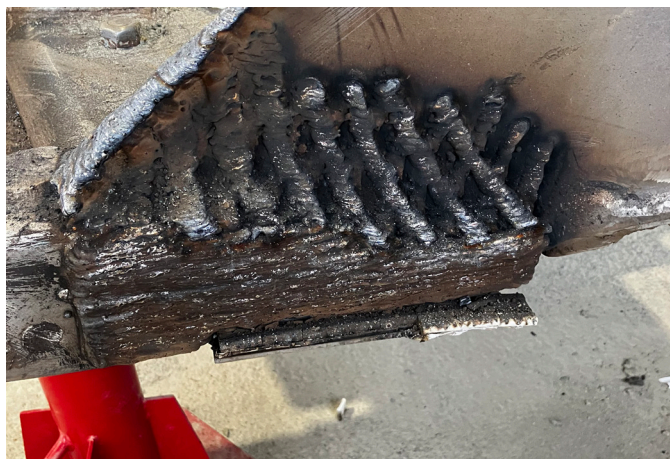
Figure 4 A.) UTP ROBOTIC CHROMELESS 600 weld overlay welded in PF position with oscillated beads and using pulse technique

For the overlay layer, we recommended a martensitic alloy to avoid high-Cr (VI) exposure in the welding fumes. High Cr content welding consumables with 25Cr-5C chromium-carbide-based solutions require extensive protection of the welder to avoid exposure to Cr (VI). For this reason, we opted for a 600 HB martensitic alloy, selecting UTP ROBOTIC CHROMELESS 600 instead of our conventional 600 HB filler metal.

- » On the bucket's exterior, we applied a globular arc transfer with horizontal stringer beads (Figure 4 A).
- » On the sidewall edges, we used a pulse technique with an oscillating motion from bottom to top (Figure 4 B).

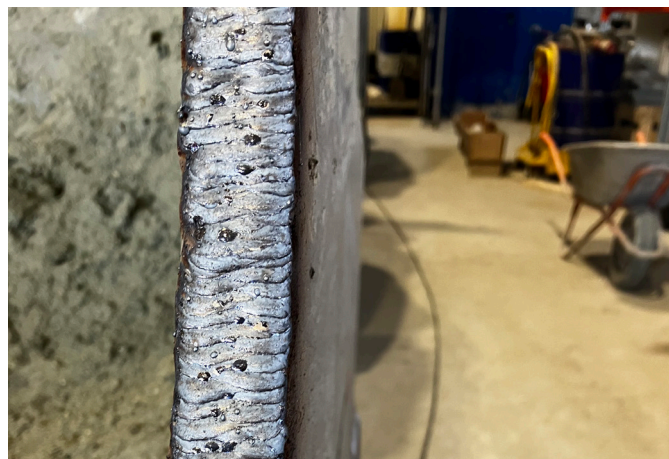
Figure 4 B.) Buffer layer applied using the all-positional rutile Böhler FOXcore 309L-T1 welding wire
