HOW TO PROTECT THE EXPOSED SURFACES OF A LADLE AND A CHUTE IN FOUNDRIES

A nickel smelter case study

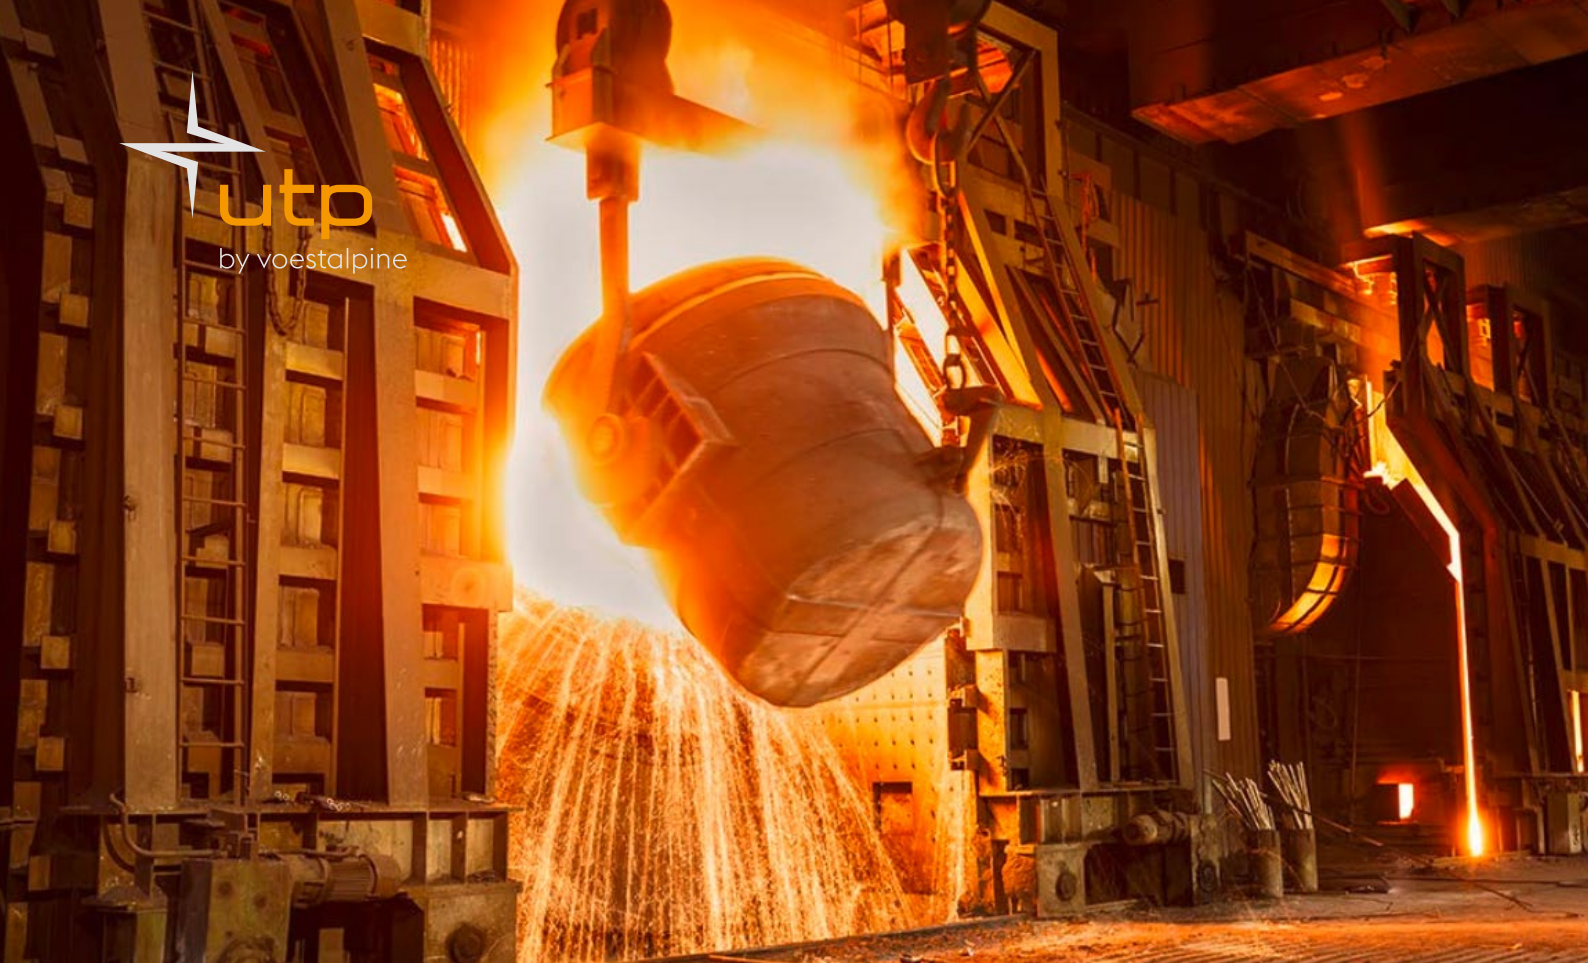
Figure 1: Pouring ladle in action. (Source: <https://www.eastcarb.com/ladle-furnace/>)

In metalmaking, a ladle (Figure 1) is a bucket-shaped vessel used to transport and pour molten metal. Ladles are typically, though not exclusively, used in foundries for casting, transferring, or treating molten metal and can have a capacity of up to 300 tonnes.

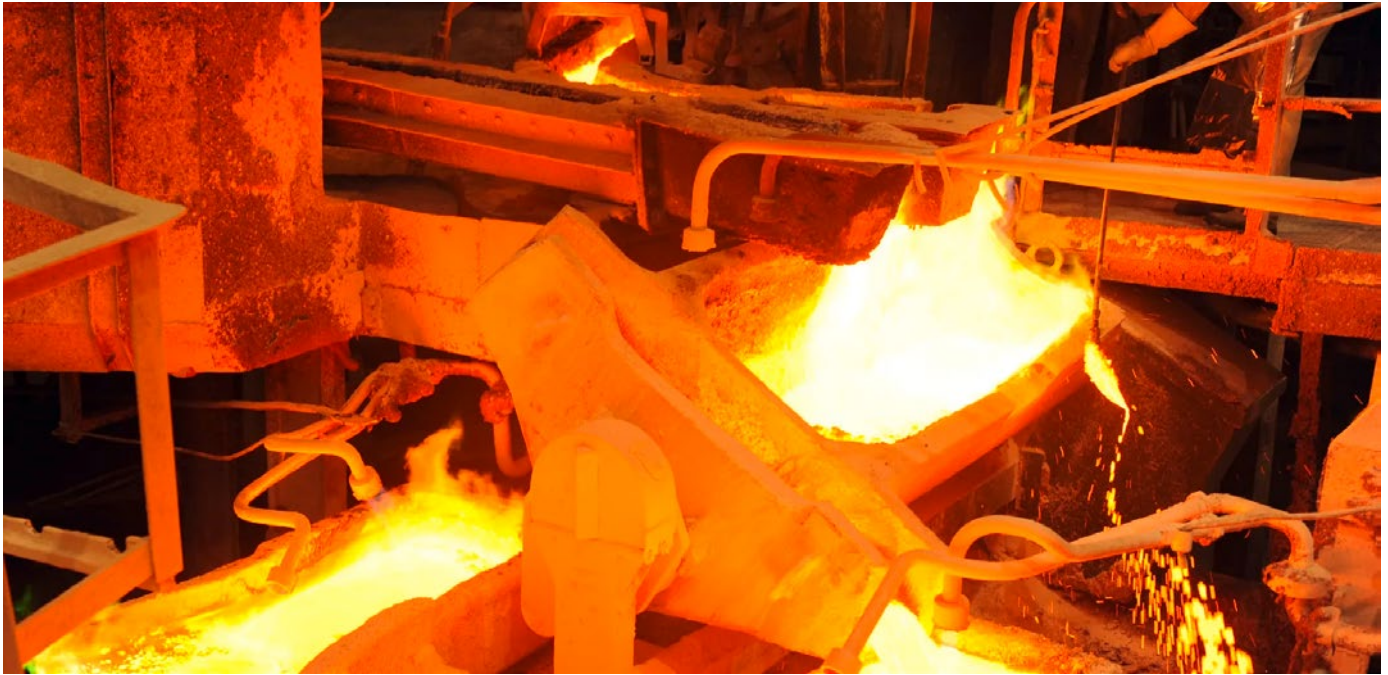
The complementary tool to the ladle is the chute (Figure 2), which ensures proper and smooth pouring of molten metal into or out of the ladle.

Figure 2: Chute in operation. (Source: <https://www.manager-magazin.de/unternehmen/metall-raubzug-aurubis-beziffert-schaden-nach-inventur-auf-185-millionen-euro-aktie-steigt-a-21bbbc16-959c-489f-8784-3fd2069ad778>)

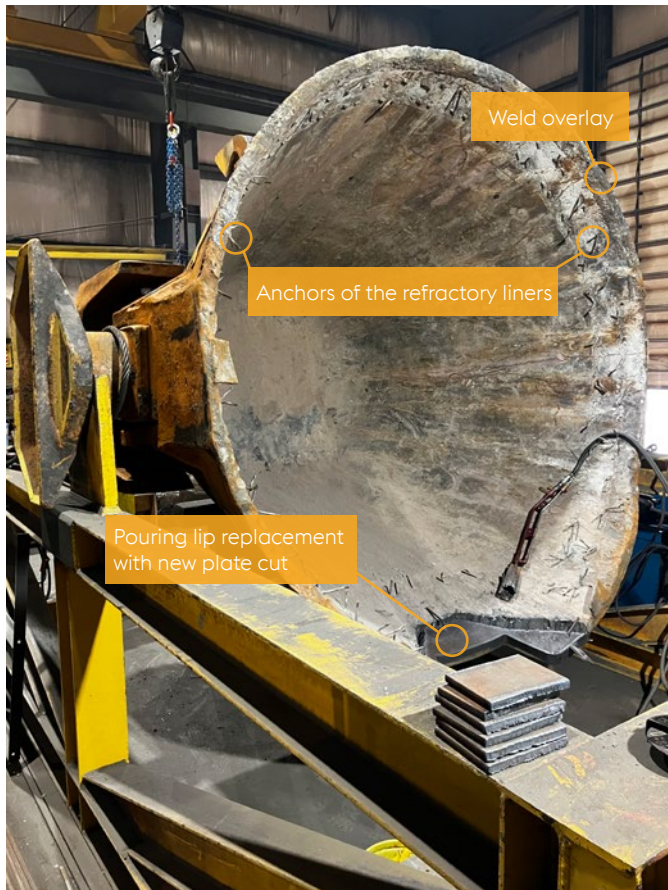
A $\varnothing 2500$ mm ladle with around 2000 mm depth and 100-180 mm wall thickness (Figure 3) and a 4000 mm long cast chute (Figure 4) are the subjects of this case study. Both the ladle and the chute are made of cast steel and are used for molten nickel transportation.

The restoration of the ladle began with the removal of the refractory lining. This state can be seen in Figure 3, as the welding work begins.

Figure 3: Repair work on a casting ladle in a workshop with refractory materials removed. Note the anchors of the refractory lining and the surface where hardfaced protection against the molten metal has been applied.

The welding phase includes both joining and hardfacing. As can be seen at the bottom edge of Figure 3, the pouring lip part was severely worn, making replacement necessary. This replacement process can be seen in the figure. The removed lip is being replaced with a new steel plate that has been cut to size and prepared for joining (Figure 5).

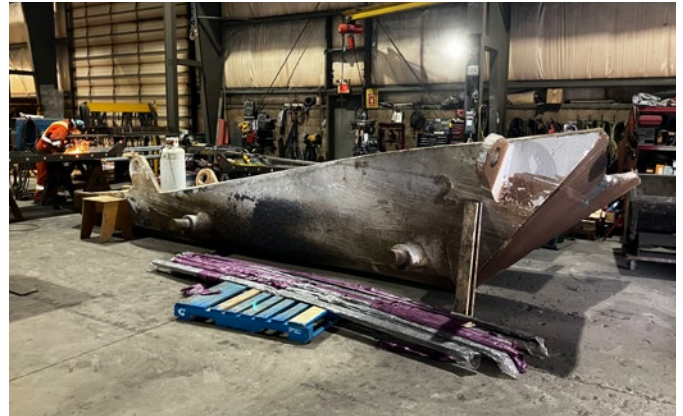
Figure 4: Molten nickel chute, side view.

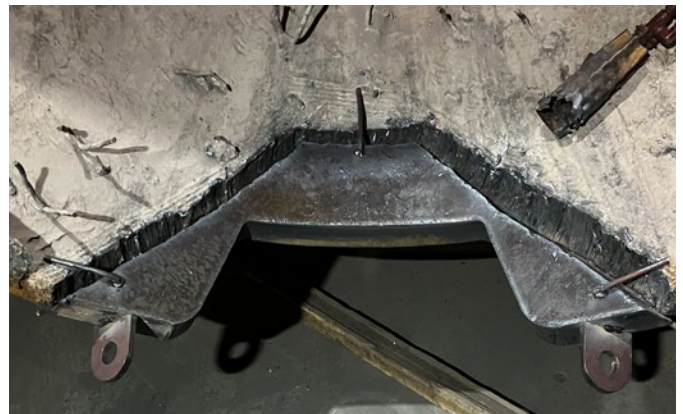
Figure 5: Pouring lip replacement in progress.

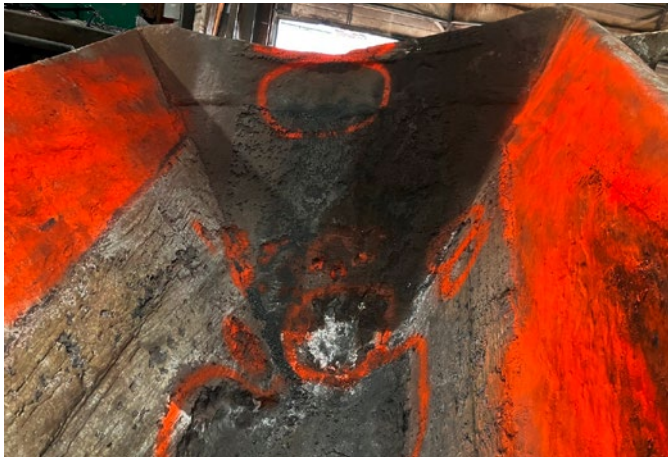
The stress is more evident in this case of a chute whose inner surface was not lined with refractory material, as the molten metal affected the entire surface more actively, which can be seen in on Figure 6.

Figure 6: The interior view of a worn chute from a nickel smelter.

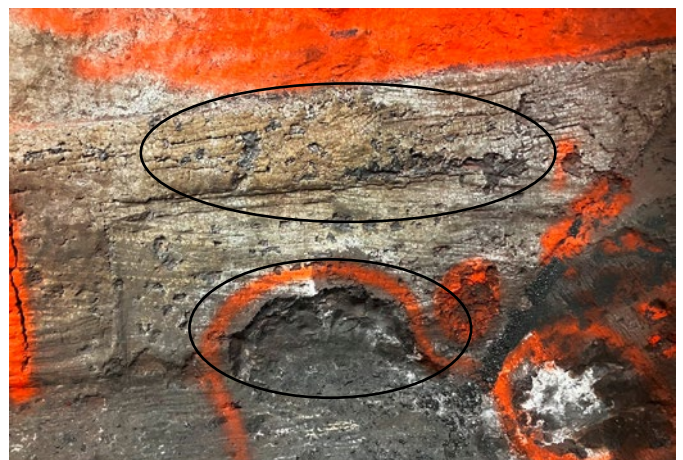
Why is it our goal to find a more reliable solution for hardfacing? The reason is that the overlay mentioned above tends to spall prematurely. The spalling phenomenon is clearly visible on the bottom and inside of the chute. Figure 7 provides a better understanding and a basis for comparison. The black ellipse marks the normal destruction of the overlay caused by erosion from molten nickel flow in the chute. This wear is predictable, so maintenance intervals can be adjusted accordingly. However, the orange ellipse indicates spalling that represents premature failure. This is unpredictable and must therefore be eliminated in terms of maintenance.

Figure 7: Close-up of a nickel chute. Note the surface defects caused by erosion (small ellipse) and spalling (big ellipse).
